Quality Assurance and Source Inspection

Contract #: 04-0120F4Cty: SF/ALA Rte: 80 PM: 13.2/13.9File #: 1.28**WELDING INSPECTION REPORT****Resident Engineer:** Casey, William**Address:** 333 Burma Road**City:** Oakland, CA 94607**Report No:** WIR-028571**Date Inspected:** 11-Oct-2012**Project Name:** SAS Superstructure**OSM Arrival Time:** 700**Prime Contractor:** American Bridge/Fluor Enterprises, a JV**OSM Departure Time:** 1730**Contractor:** American Bridge/Fluor Enterprises, a JV**Location:** Job site**CWI Name:** Patrick Swain**CWI Present:** Yes No**Inspected CWI report:** Yes No N/A**Rod Oven in Use:** Yes No N/A**Electrode to specification:** Yes No N/A**Weld Procedures Followed:** Yes No N/A**Qualified Welders:** Yes No N/A**Verified Joint Fit-up:** Yes No N/A**Approved Drawings:** Yes No N/A**Approved WPS:** Yes No N/A**Delayed / Cancelled:** Yes No N/A**Bridge No:** 34-0006**Component:** OBG**Summary of Items Observed:**

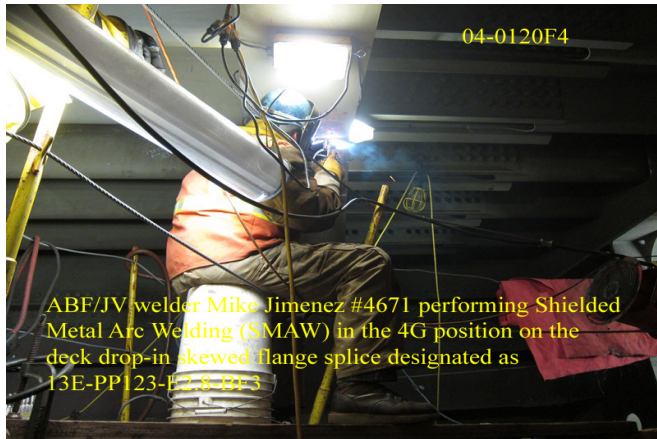
The ABF welder Rick Clayborn #2773 was observed later in the shift performing Shielded Metal Arc Welding (SMAW) in the 4G position utilizing the Caltrans approved Welding Procedure Specifications ABF-WPS-D1. 5-1004-Repair at the above mentioned location. The weld and surrounding area was brought to a temperature of 325°F by the use of induction heaters and maintained throughout the welding process. The repairs were then observed to be post heated at 450°F for one hour as required by the applicable repair document. Due to the first time repair at this location an approval for repair document was not required.
